Bearing damage and failure analysis

SKF®

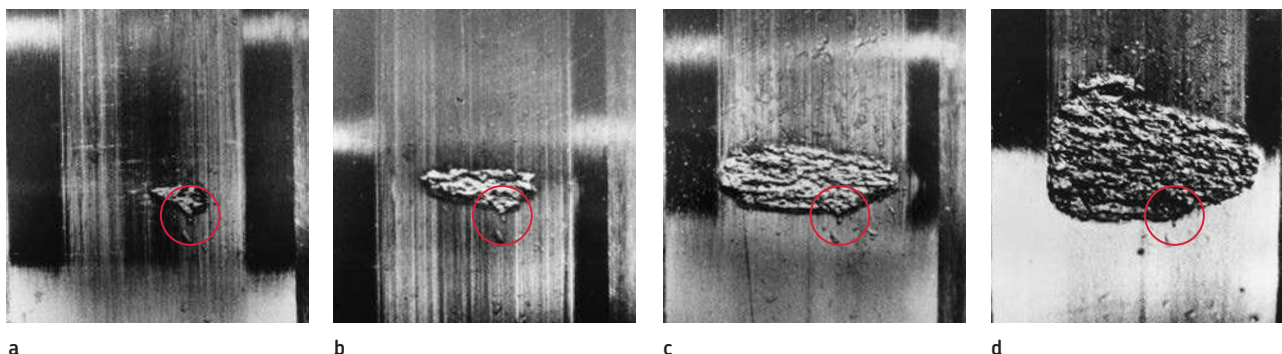
Fig. 1

A hard contaminant was over-rolled and made an indentation in the inner ring raceway of a cylindrical roller bearing (a). The surface initiated fatigue resulting in a spall started just behind the indentation. Over a period of time, spalling became more and more pronounced (b, c). If the machine was not stopped in time, secondary damage to machine components could have occurred. The initial indentation is no longer recognizable (d).

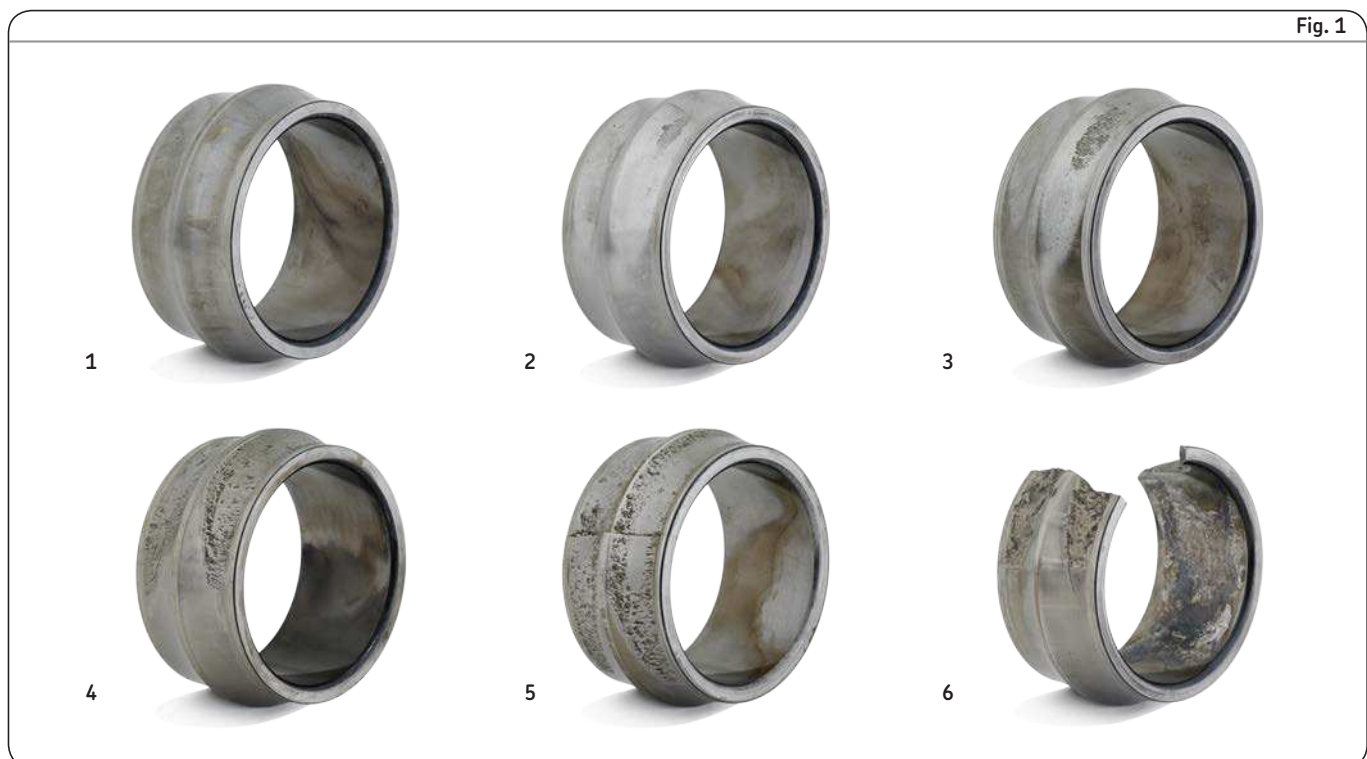
Fig. 1 shows the progress of damage as illustrated in **diagram 1**:

- 1 Bearing exhibits incipient abrasive wear.
- 2 First spall, detected by SKF enveloped acceleration technology.
- 3 Spalling has developed to an extent that the damage can be detected by standard vibration monitoring.
- 4 Advanced spalling causes high vibration and noise levels and an increase in operating temperature.
- 5 Severe damage occurs: fatigue fracture of the bearing inner ring.
- 6 Catastrophic failure occurs with secondary damage to other components.

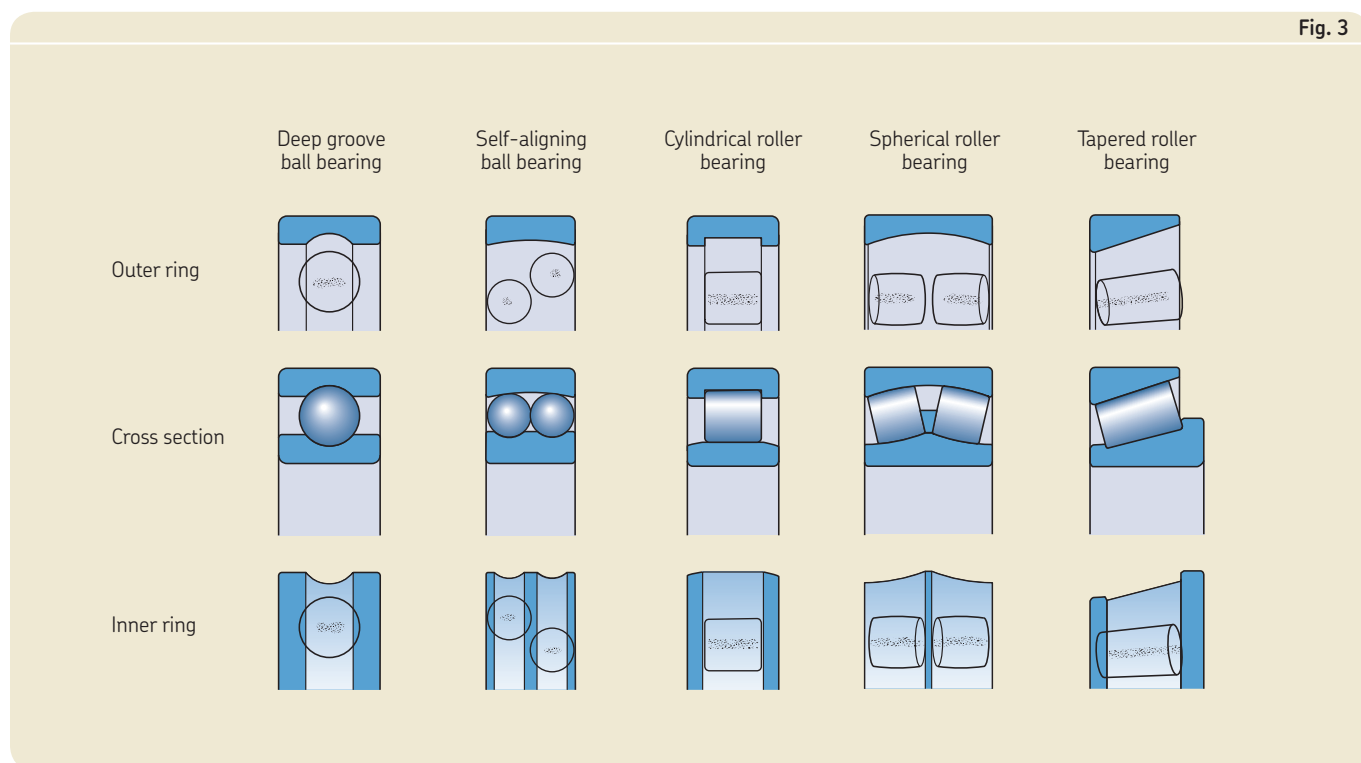
For simplicity, examples of deep groove ball bearings and thrust ball bearings are shown in this chapter. For other bearing types, the path patterns can vary due to the contact area, which depends on the bearing type, configuration, load, and clearance. Some examples of raceway contact areas are shown in **fig. 3**.

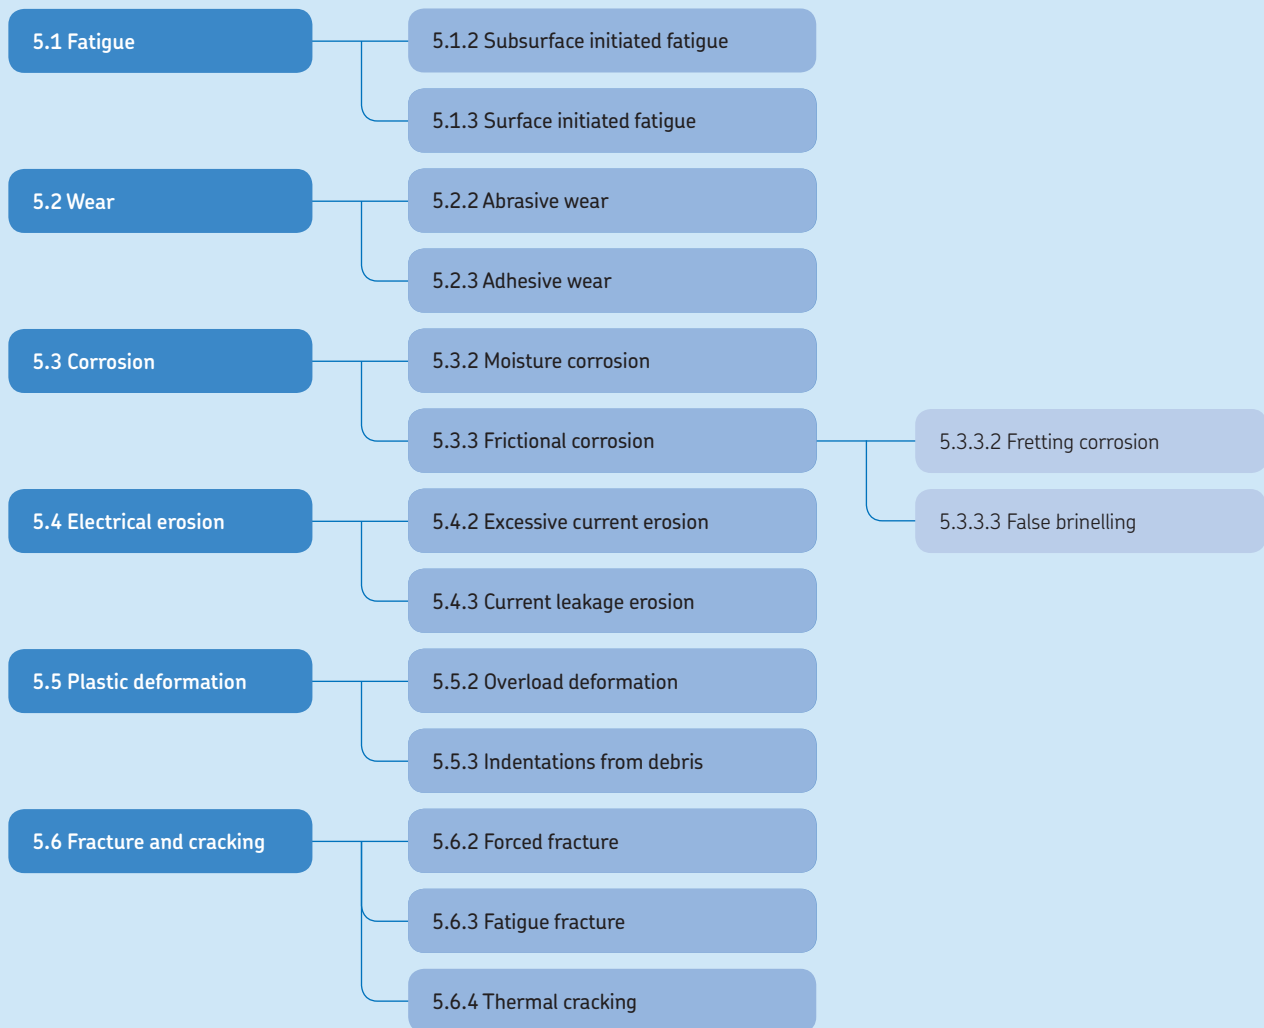
SKF classification adapted from ISO 15243:2004

Numbering follows ISO 15243:2004 subclause numbers.

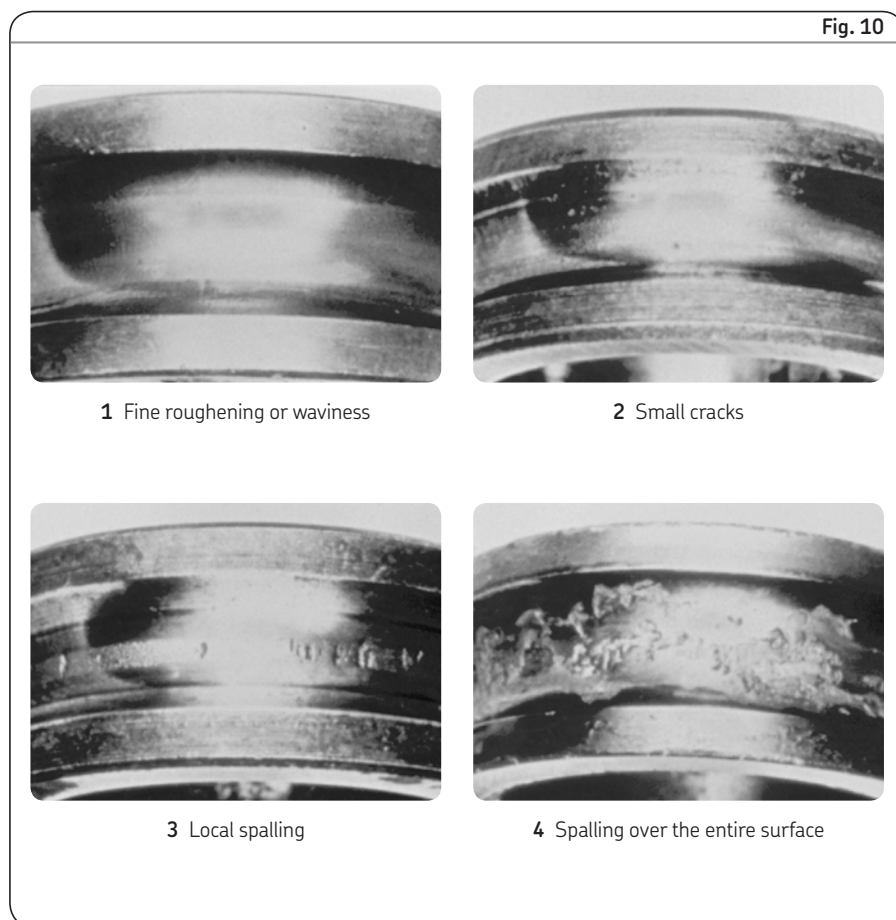
Progress of surface initiated fatigue on the inner ring of a deep groove ball bearing

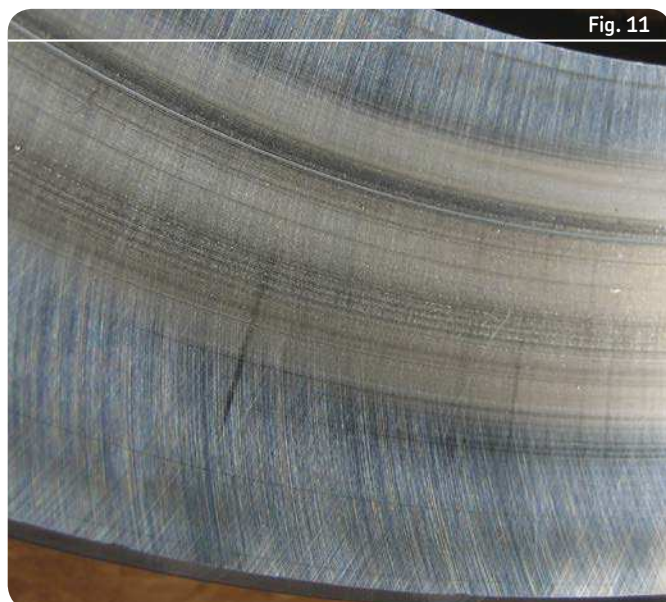
Light abrasive wear on the outer ring of a spherical roller thrust bearing

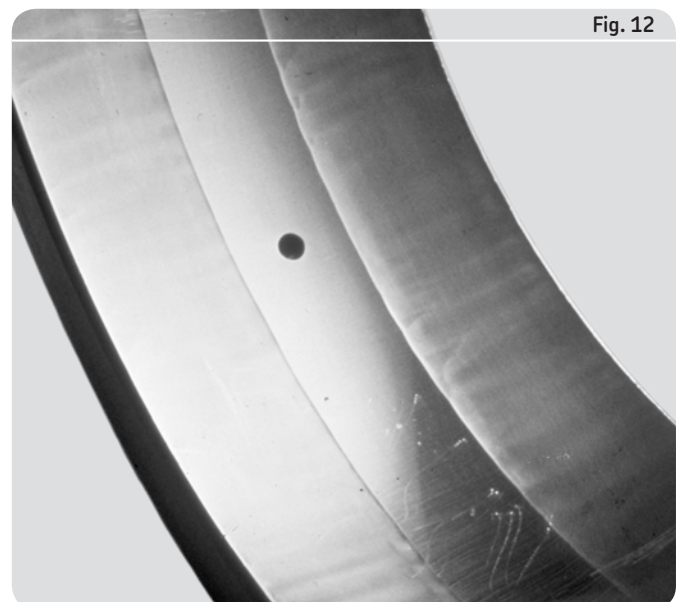
Advanced abrasive wear on the outer ring of a spherical roller bearing (dull and matt raceways)

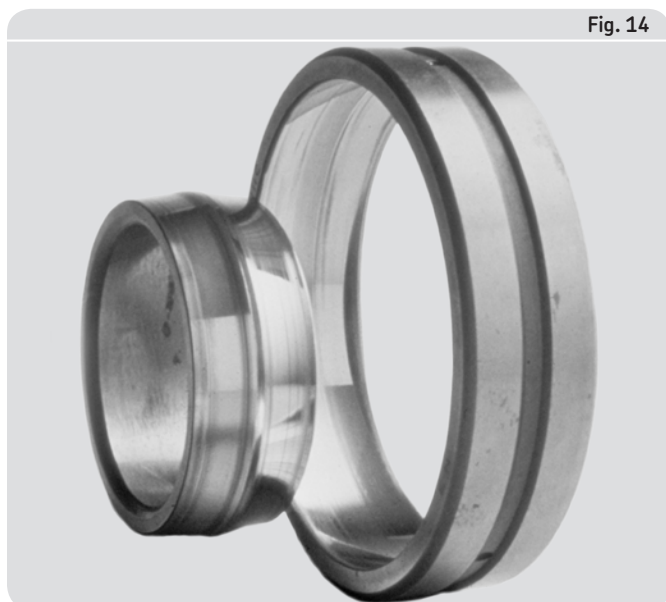
Polishing wear (mirror-like raceway surfaces) on the inner and outer rings of a spherical roller bearing

Polishing wear is a special form of abrasive wear. The raceway surfaces of new bearings are shiny but not highly reflective (mirror-like). Real mirror-like surfaces in a bearing that has been in service (→ **fig. 14**) result from inadequate lubrication caused by a thin oil film, and particles that are acting as a polishing agent. This allows metal-to-metal contact, which leads to abrasive wear and plastic deformation of the asperities (→ **fig. 15**). The surfaces may become extremely shiny – all depending on the size of the particles, their hardness and running time.

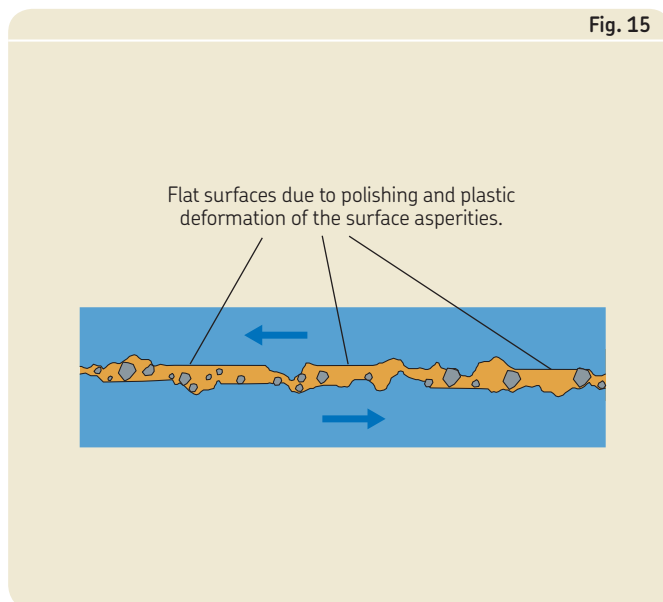
Process of polishing wear in a bearing

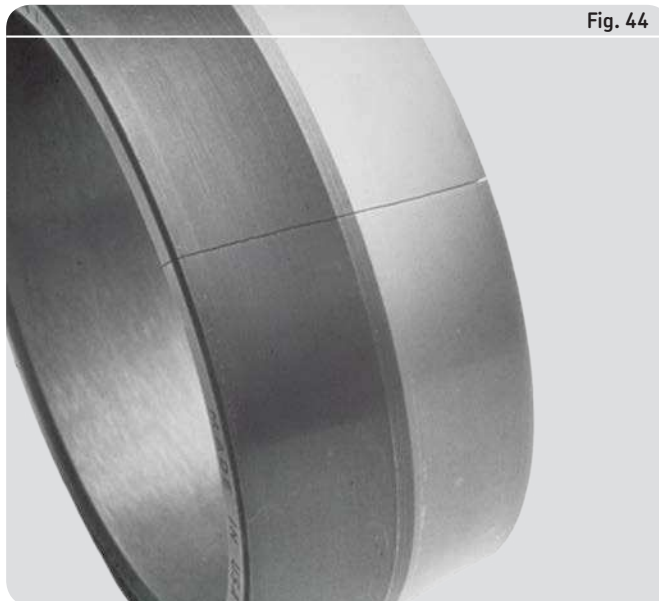
Fig. 44

Fracture on the large shoulder of a tapered roller bearing inner ring resulting from rough treatment

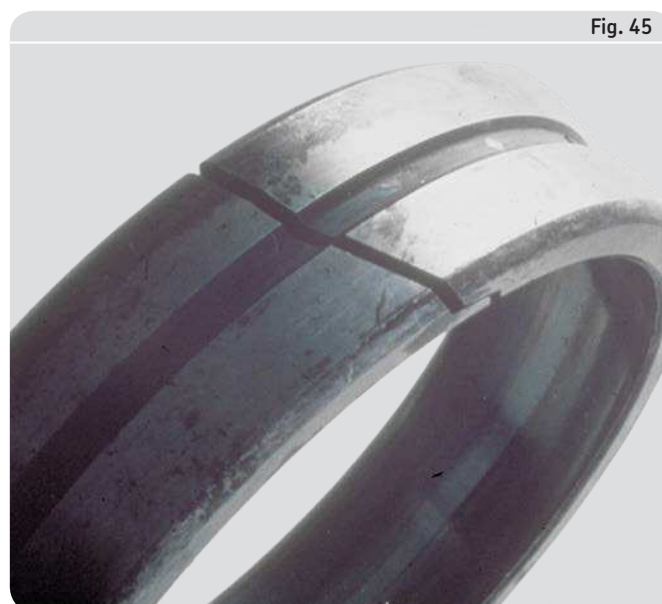
Fatigue fracture of an outer ring of a spherical roller bearing

A fatigue fracture starts when the fatigue strength of a material is exceeded under cyclic bending. Repeated bending causes a hairline crack which propagates until the ring or cage develops a through crack.

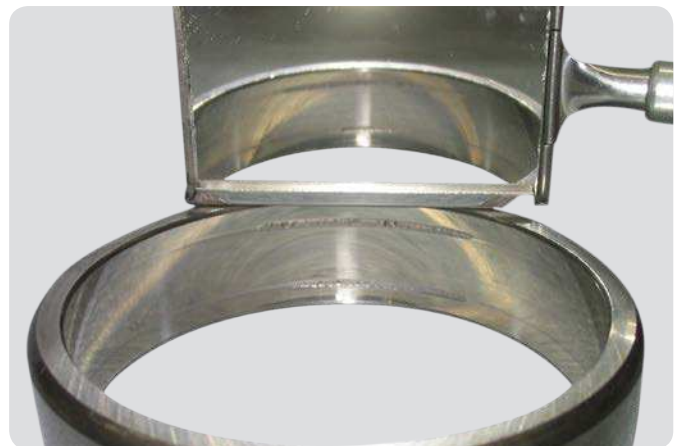
Tapered roller bearing inner ring
Spalling on one side of the raceway only, resulting from misalignment and consequent edge loading, leading to higher stress and failure

- Make sure you have the right bearing for the actual application conditions and their variations (load, temperature, speed, misalignment, mounting, etc.)
- Make sure the lubrication is adequate: right lubricant, right quantity, right time
- Improve the surface separation capability of the lubricant (lubricant viscosity, additives, grease formulation)
- Check the lubricant quality at regular intervals
- Reduce the contamination (improved sealing, oil filtration)

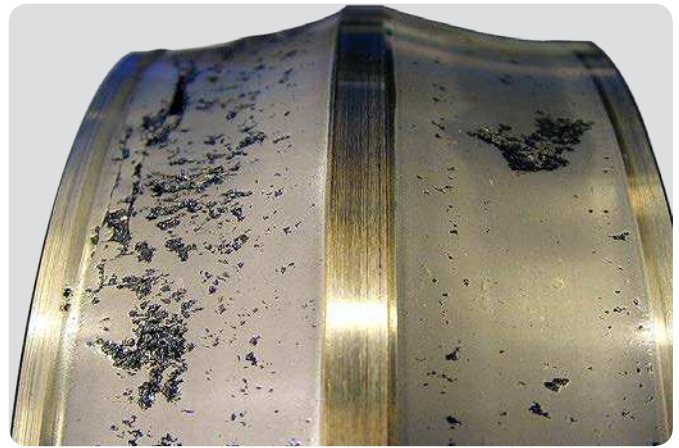
Spherical roller bearing inner ring
Inadequate lubrication, surface distress with incipient spalling

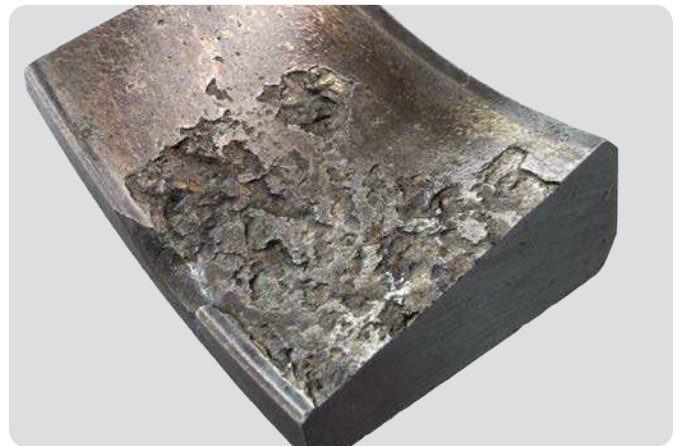
Spherical roller bearing outer ring
Initially, abrasive wear due to contamination, developed into surface distress and advanced spalling

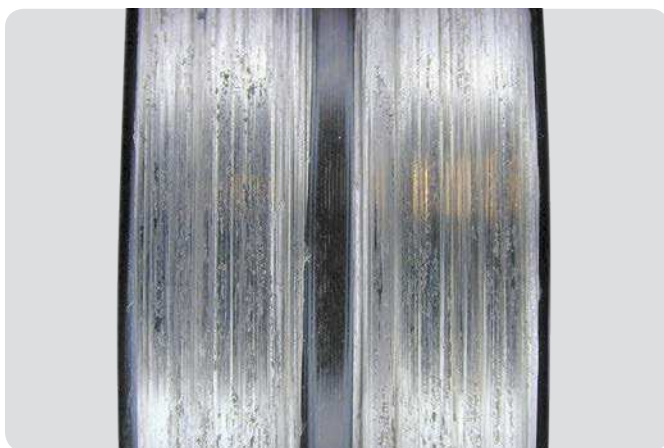
Abrasive wear of the cage pockets due to inadequate lubrication and vibration. Cage bars worn away.

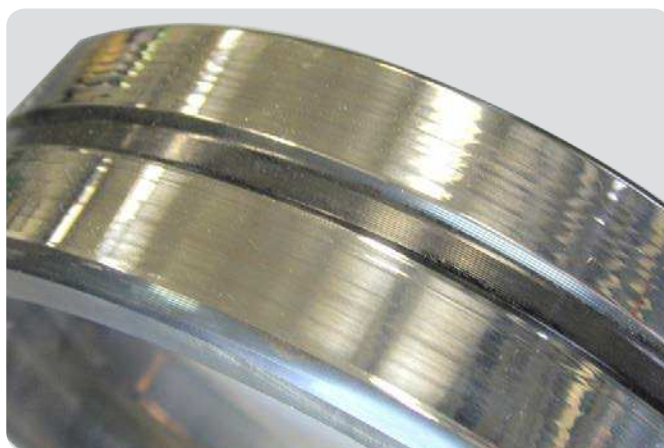
Spherical roller bearing outer ring

Ring creep in the housing from inadequate fit – abrasive wear marks on the outside surface

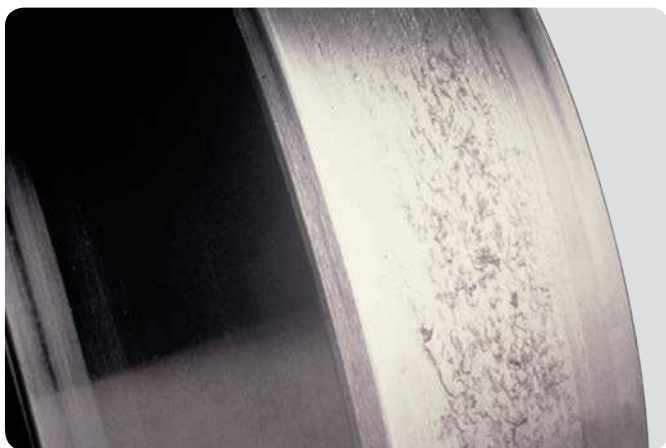
Spherical roller bearing inner ring
Too low load combined with inadequate lubrication

- Make sure the bearing is adequately loaded
- Make sure the sealing arrangement is operating efficiently
- Consider bearing downsizing
- Verify lubricant selection (viscosity, AW and EP additives)
- Consider using coatings
- Consider using hybrid bearings

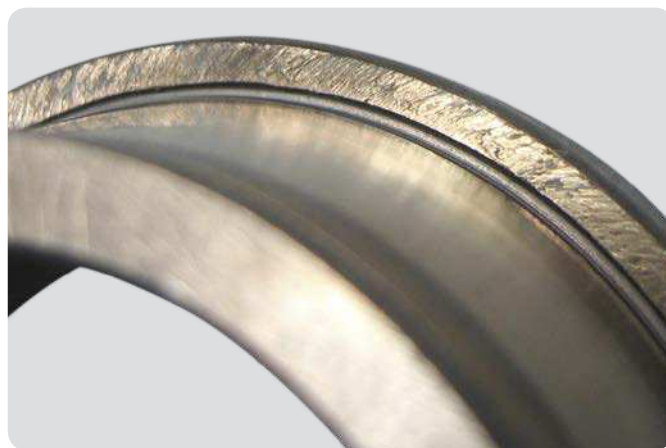
Tapered roller bearing inner ring
Contamination and inadequate lubrication resulting in adhesive wear of the flange as well as a shiny raceway

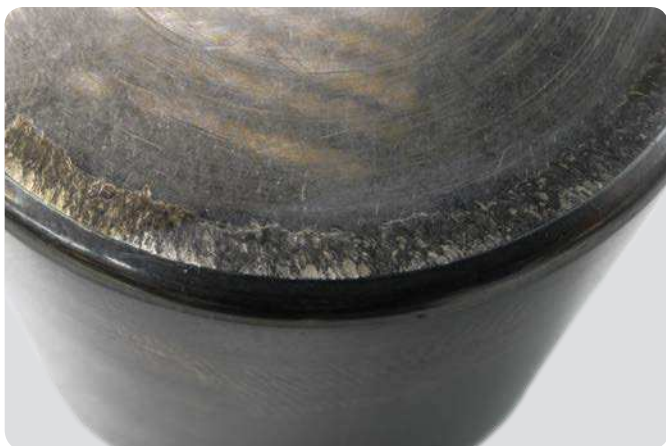
Tapered roller bearing – roller
Contamination and inadequate lubrication leading to adhesive wear marks on the large roller end face

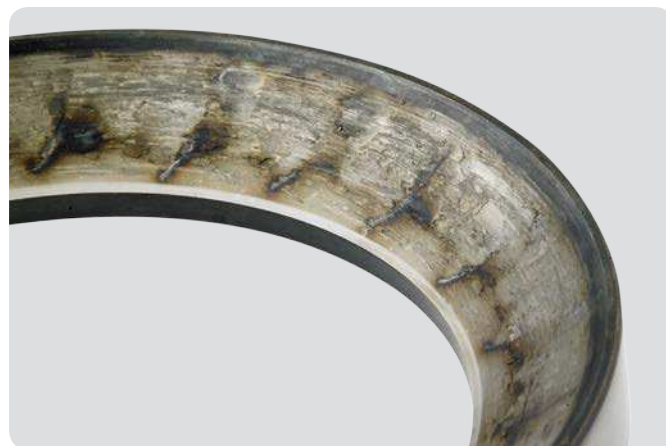
Spherical roller thrust bearing outer ring
Initially adhesive wear, then excessive heat generation, finally jamming

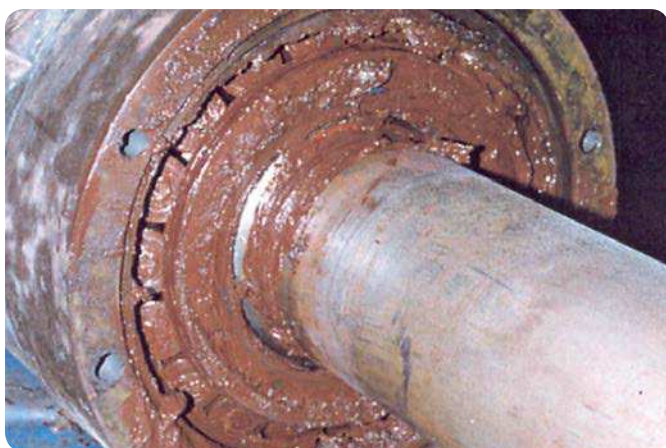
Tapered roller bearing in a pump unit
 Seal failure, bearing corrosion and reddish discolored grease

- Make sure the bearing arrangement is adequately protected
- Consider using sealed bearings in respect of the operating environment
- Make sure the lubrication is adequate: right lubricant, right quantity, right time
- Do not unpack bearings until mounting them
- Protect mounted bearings adequately

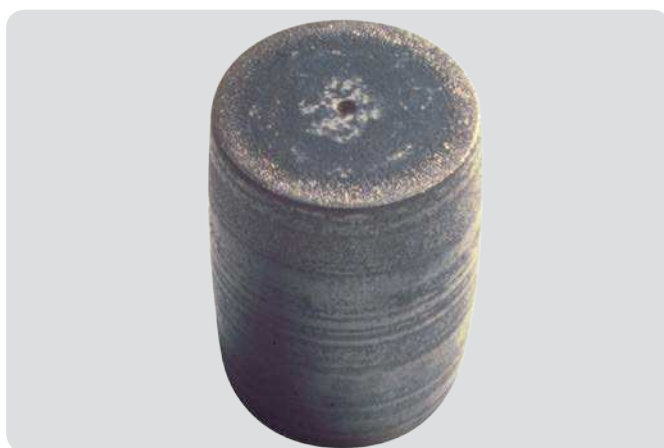
Spherical roller bearing – roller
 Corroded roller due to severe water penetration into the bearing

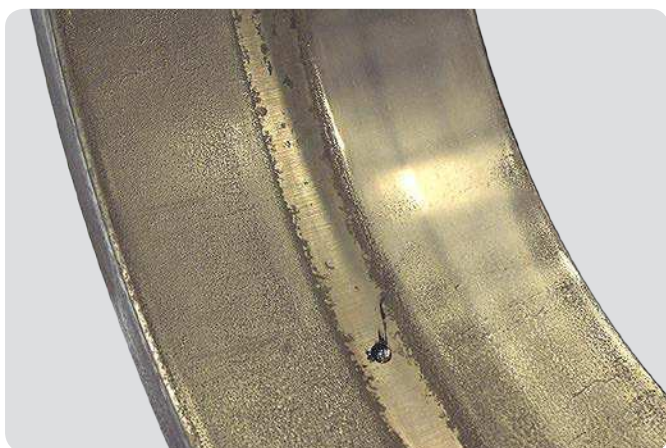
Spherical roller bearing outer ring
 Sealing arrangement failure, corrosive substance entered the bearing

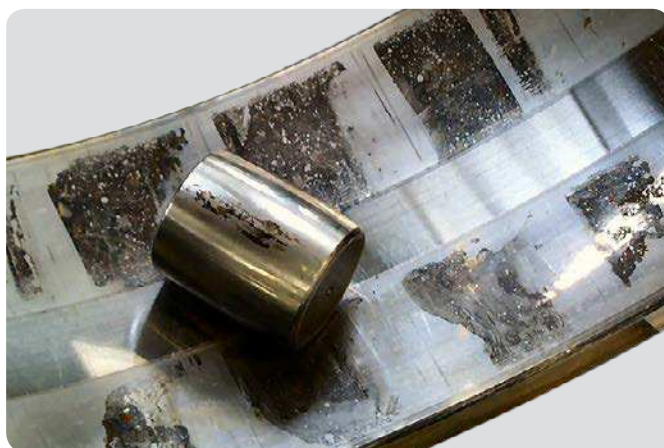
Spherical roller bearing outer ring and roller
 Too high water content in the lubricant, standstill corrosion of raceway at roller pitch

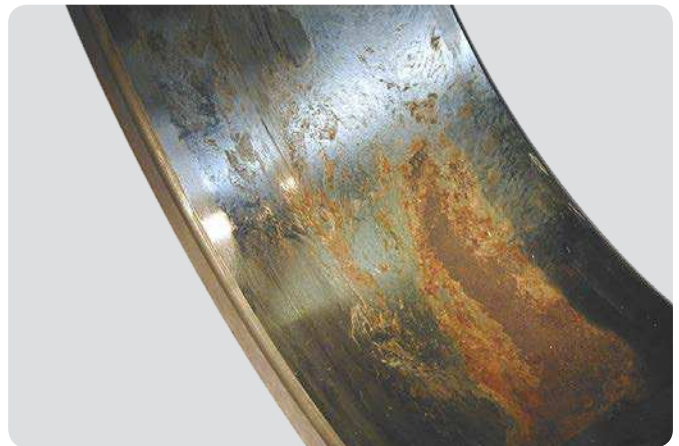
Cylindrical roller bearing inner ring
Inappropriate shaft fit (too loose)

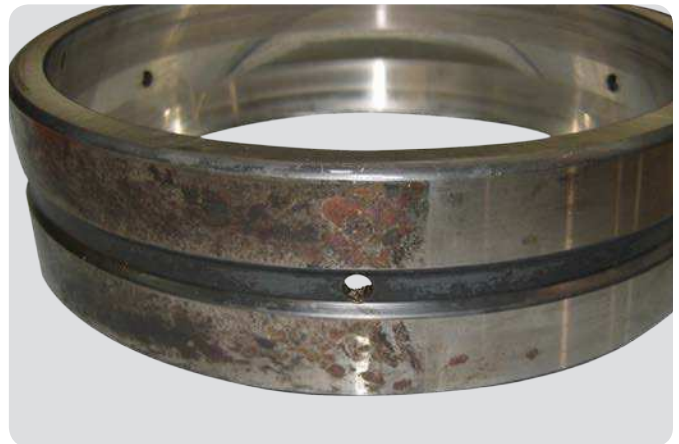
Spherical roller bearing outer ring
Brown coloured fretting corrosion area from micromovements due to advanced raceway spalling, with scratches due to dismounting

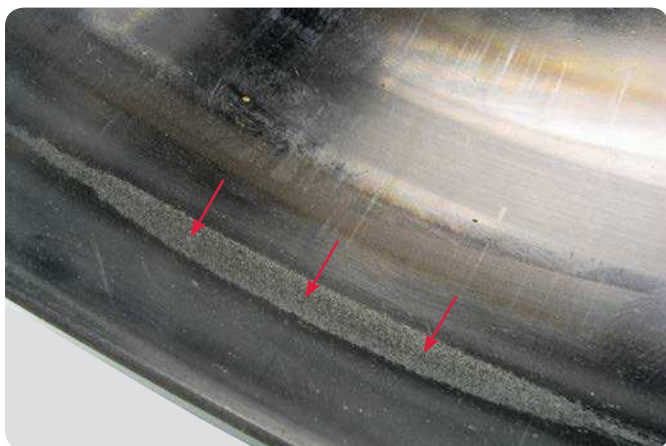
Spherical roller bearing outer ring
Damage in early stage: dull grey zone with small shallow craters

- Use symmetric cabling
- Make sure the stator and rotor are properly aligned
- Use insulated bearings (INSOCOAT or hybrid bearings)
- Make sure earthing connections are installed properly

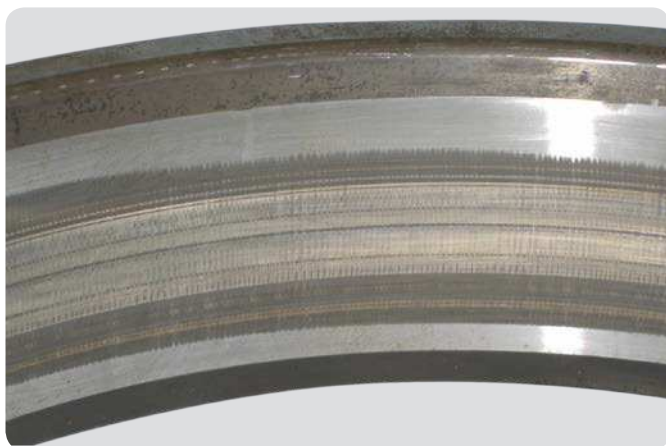
Cylindrical roller bearing outer ring
Early stage of washboarding

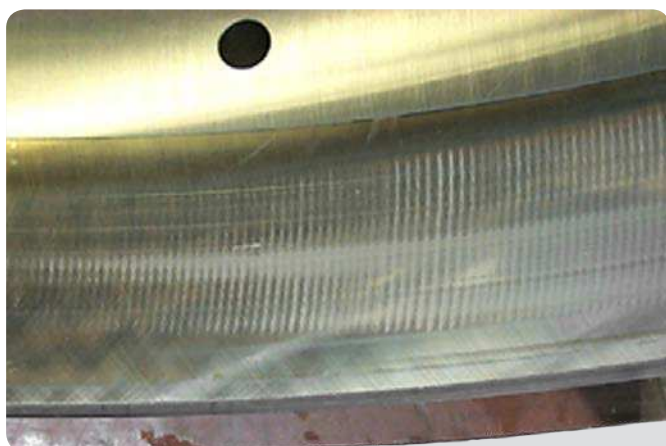
Spherical roller bearing outer ring
Current leakage

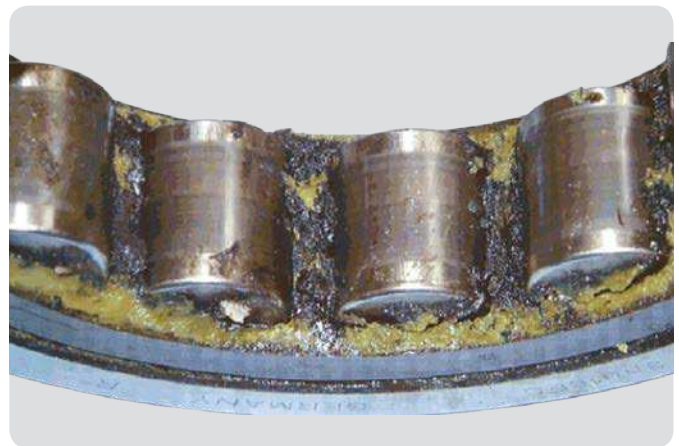
Cylindrical roller bearing outer ring with cage, rollers and grease
Current leakage resulted in burnt grease (black) on the cage bars

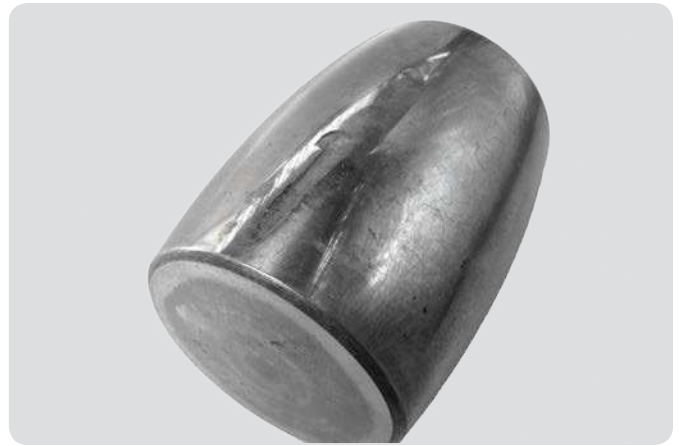
Spherical roller thrust bearing – roller
Heavy impact, plastic deformation

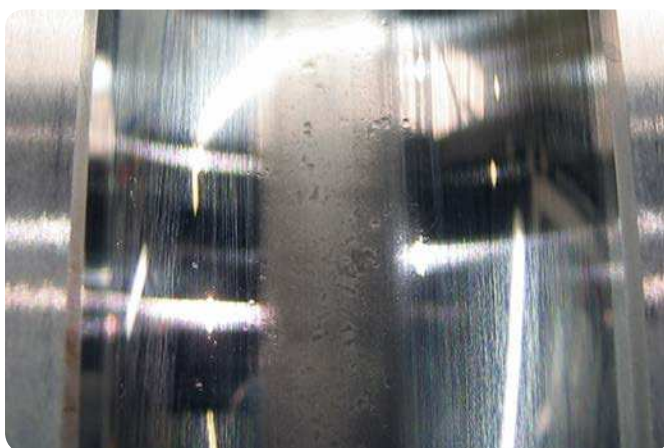
Deep groove ball bearing inner ring
Dents resulting from overrolling of hard particles – inadequate sealing arrangement

- Make sure to work in clean conditions
- Use adequate sealing to protect the bearing
- Make sure the lubrication is adequate: right lubricant, right quantity, right time
- Never drop a bearing
- Treat bearings carefully

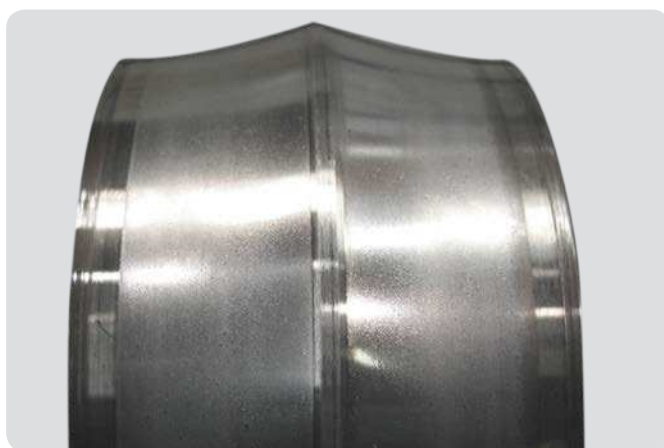
Spherical roller bearing inner ring
Many small dents resulting from overrolling of small hard particles – inadequate sealing arrangement

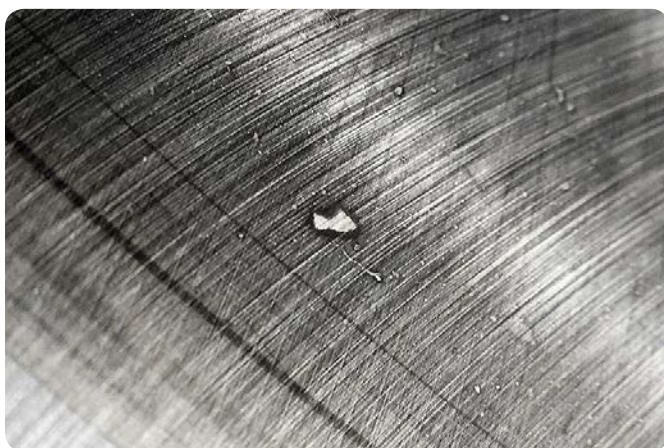
Spherical roller bearing outer ring
Overrolling of hard particles that entered the bearing during mounting – lack of cleanliness

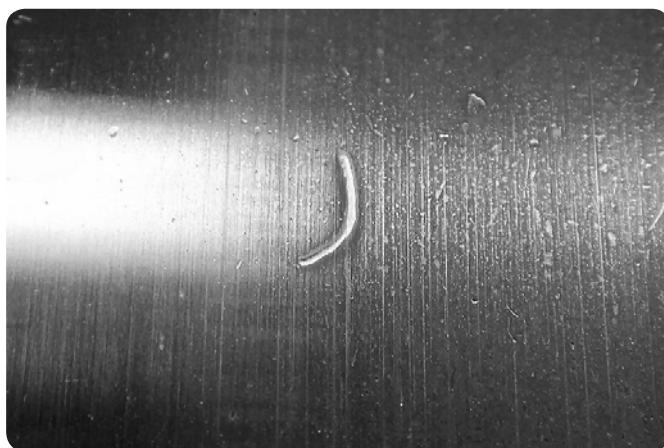
Spherical roller bearing outer ring
Overrolled swarf/chip will lead to spalling

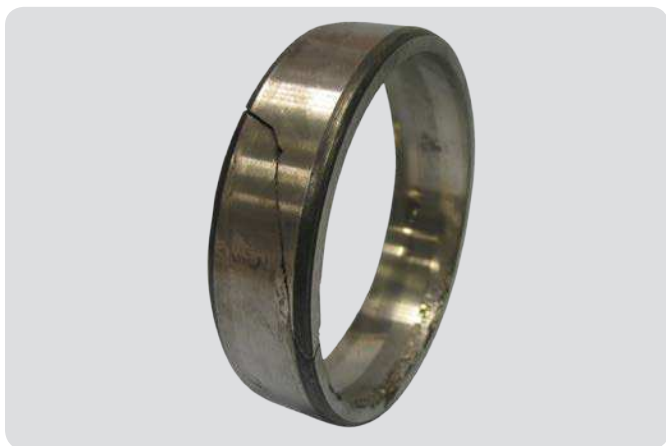
Self-aligning ball bearing outer ring
Fracture resulting from excessive misalignment and balls running over the raceway edge

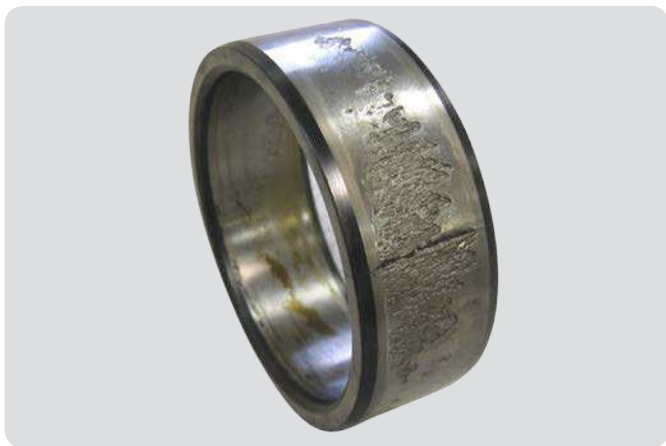
Cylindrical roller bearing inner ring

Very heavy spalling – fatigue fracture as sequential damage

- Make sure bearing seats conform to geometrical specifications
- For split housings, make sure the two halves join correctly
- Bearing seats should be clean (no swarf or chips, which could create local stress rise)
- Use appropriate tools and methods for mounting

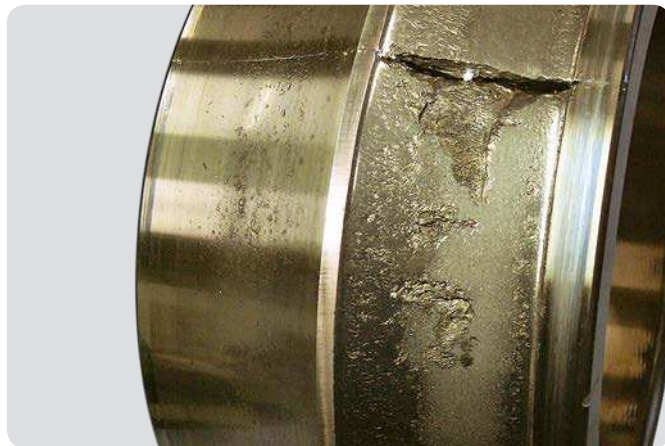
Spherical roller bearing inner ring

Very heavy spalling – fatigue fracture as sequential damage

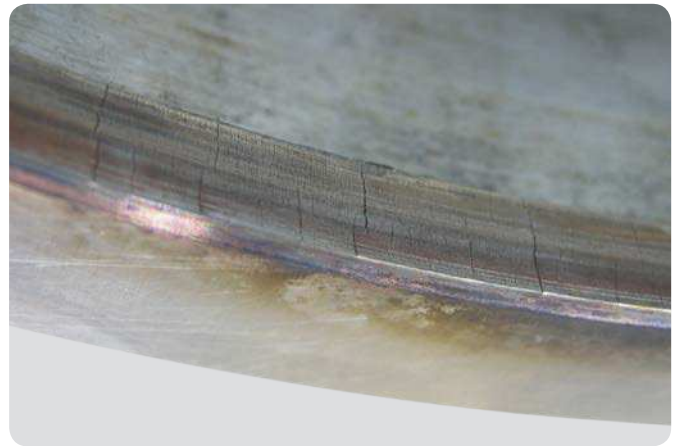
Cylindrical roller bearing outer ring
Thermal cracks at shoulder-cage contact due to inadequate lubrication

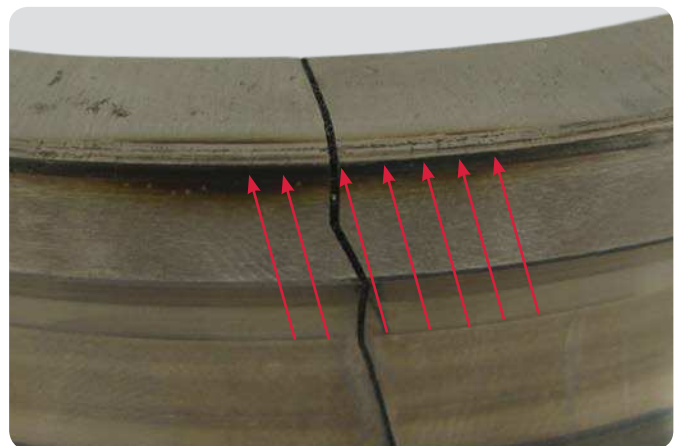
Deep groove ball bearing inner ring
Enlarged view of fractured ring, with many heat cracks along the inner ring shoulder

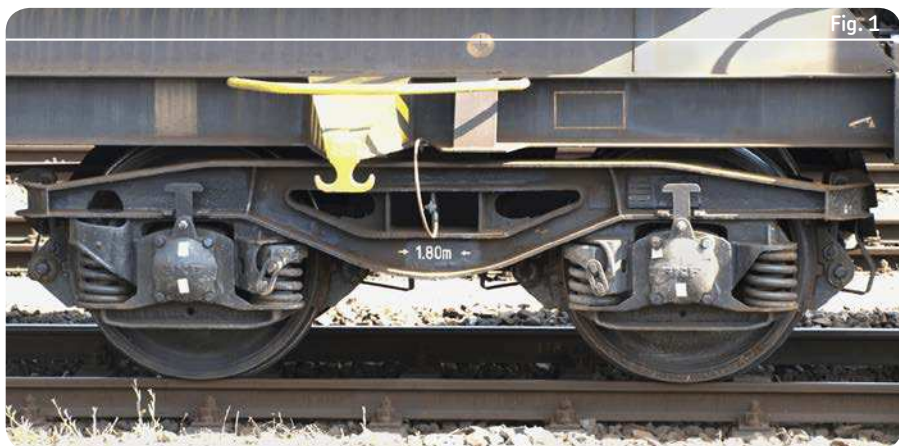
Goods wagons equipped with “Y-25” bogies, incorporating axleboxes with a double spring suspension

A train hauling cargo passed a hot box detector (a device placed at intervals on tracks to detect hot running bearings). Everything appeared normal.

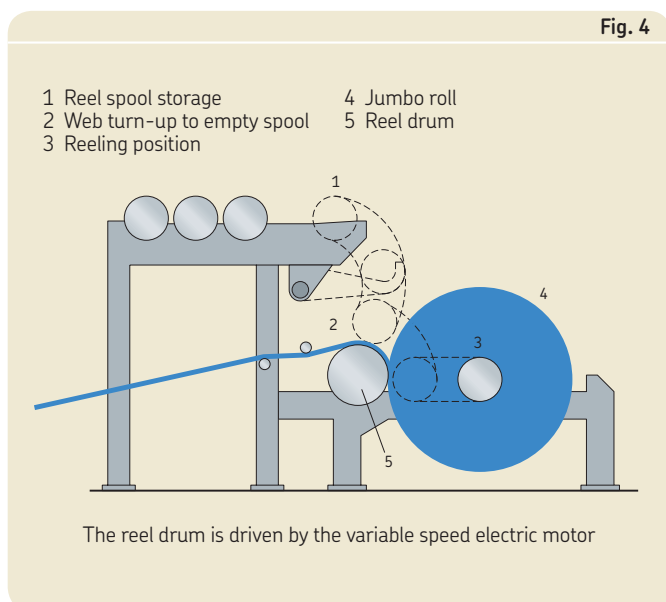
Typical layout of a Jumbo roll (reel spool)

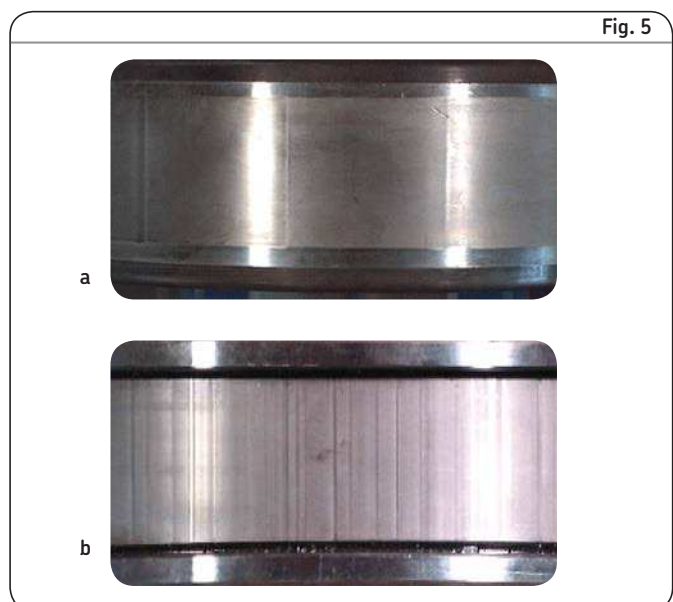
Heavy wear and vibration marks on the inner ring (a) and outer ring (b) raceways of the cylindrical roller bearing

When the bearing was cut, and a section put under a microscope, some interesting conclusions could be made:

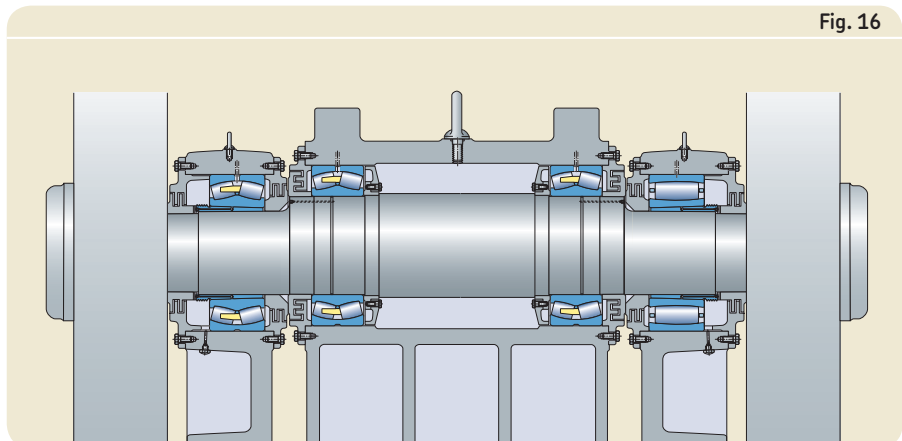
Typical jaw crusher bearing arrangement
